RESIDENTIAL PROPERTY INSPECTION

3059 Palm Hill Dr
Vista CA 92084

Nhan Nguyen
NOVEMBER 26, 2021

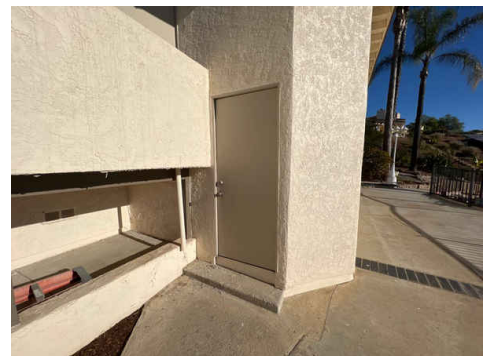
LOCKED

Exterior closet was locked, inspector was unable to access.

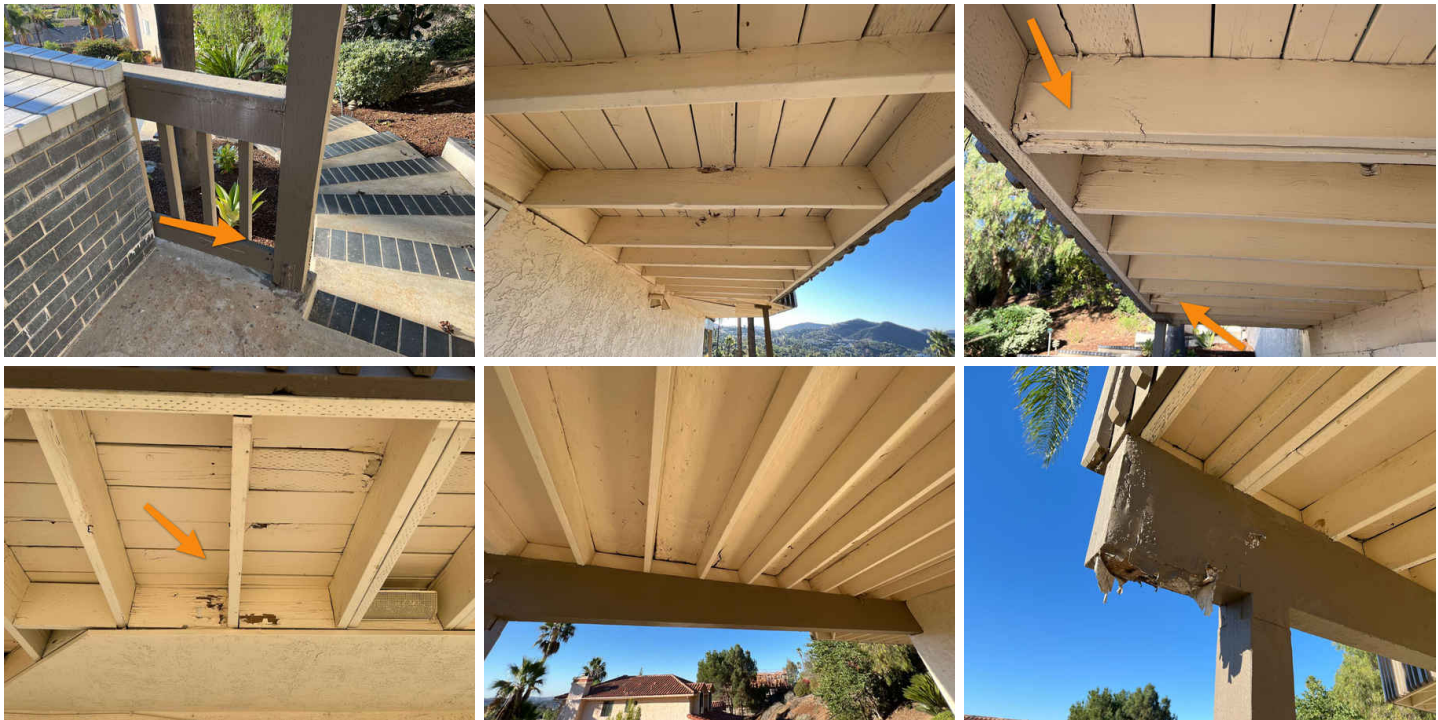
Rear of Home

Damage/deterioration noted to the patio/deck cover (May include: joists/ rafters/ support posts/ beams/ bracing/ roof decking /lathes). Refer to termite report for rot, fungus and insect damage. Recommend repair/replacement as needed by licensed professional. Not all areas may be shown.

Recommendation
Contact a qualified professional.

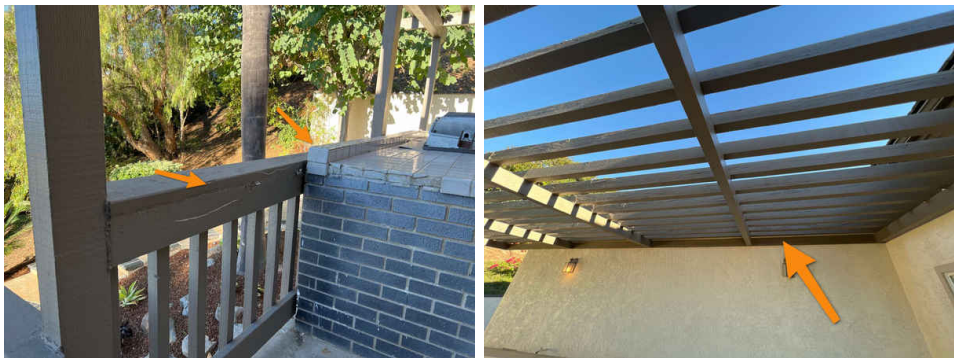
2.6.1 Eaves, Soffits & Fascia

EAVES/FASCIA- DAMAGE/DETERIORATION

Damage noted to the eaves/fascia in areas around the home. All areas might not be shown. Refer to termite report concerning rot, fungus and insect damage. Recommend repair as needed.

Recommendation
Contact a qualified professional.

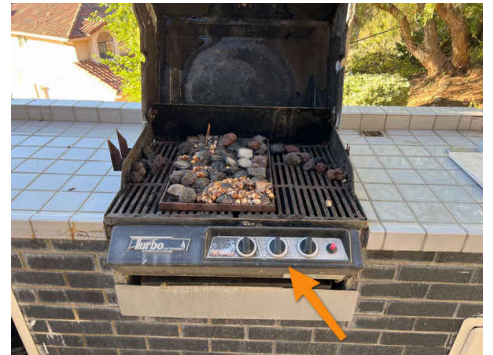
Not all of the BBQ burners responded to igniter. Recommend further investigation and correction as needed.

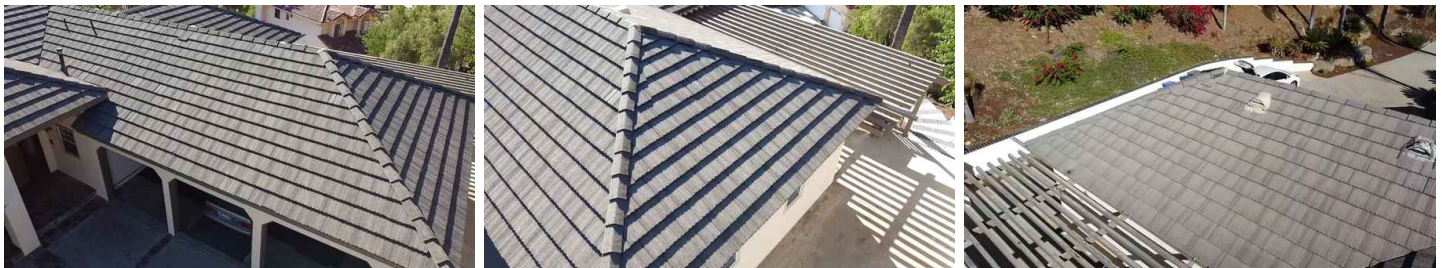
3.2.2 Tile

VALLEY TILES- PINCHED

Recommendation

Contact a qualified roofing professional.

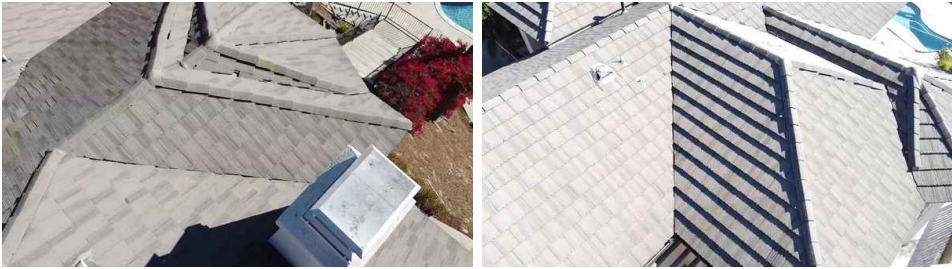
3.2.3 Tile

REPAIRS NOTED

Tile repairs/replacement noted. Inspector is unable to determine quality of repairs or product. Recommend asking seller for more detail and/or having the roof further investigated by a licensed roofer.

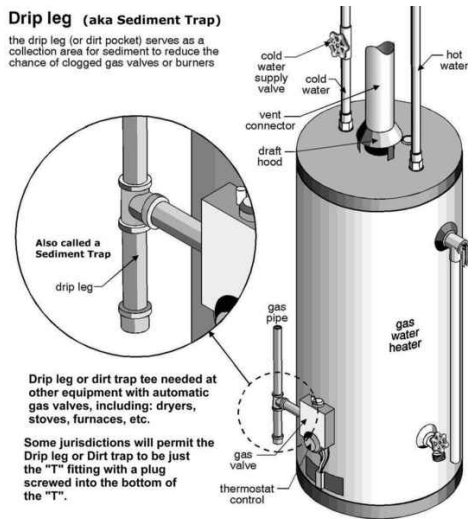
the drip leg (or dirt pocket) serves as a collection area for sediment to reduce the chance of clogged gas valves or burners

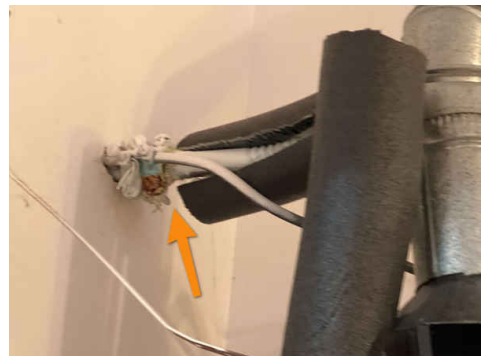
4.8.4 Hot Water Systems, Controls, Flues & Vents

WATER HEATER- CORROSION (VALVES/CONNECTIONS)

Corrosion was observed at connections/valves. Recommend further evaluation by a qualified professional.

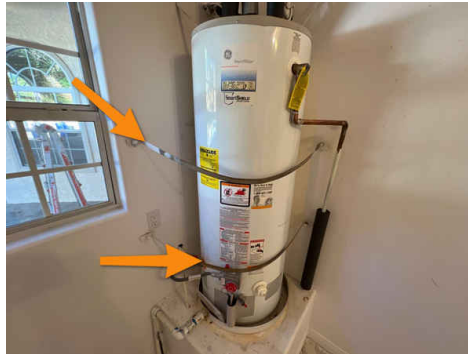
4.10.1 Laundry

CORROSION ON VALVE(S)

Corrosion noted at the water shutoff valve(s). Valve could leak at any time or may not work properly when used. Recommend further investigation and correction as needed.

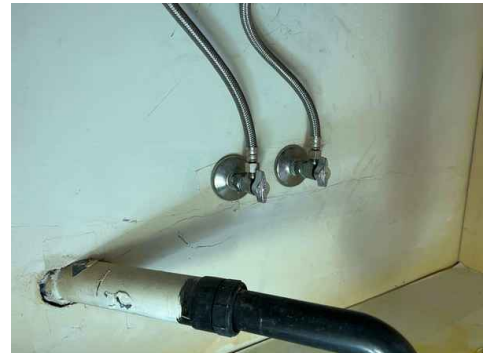
4.10.2 Laundry

LAUNDRY SINK DRAIN - CORROSION

Recommendation

Contact a qualified professional.

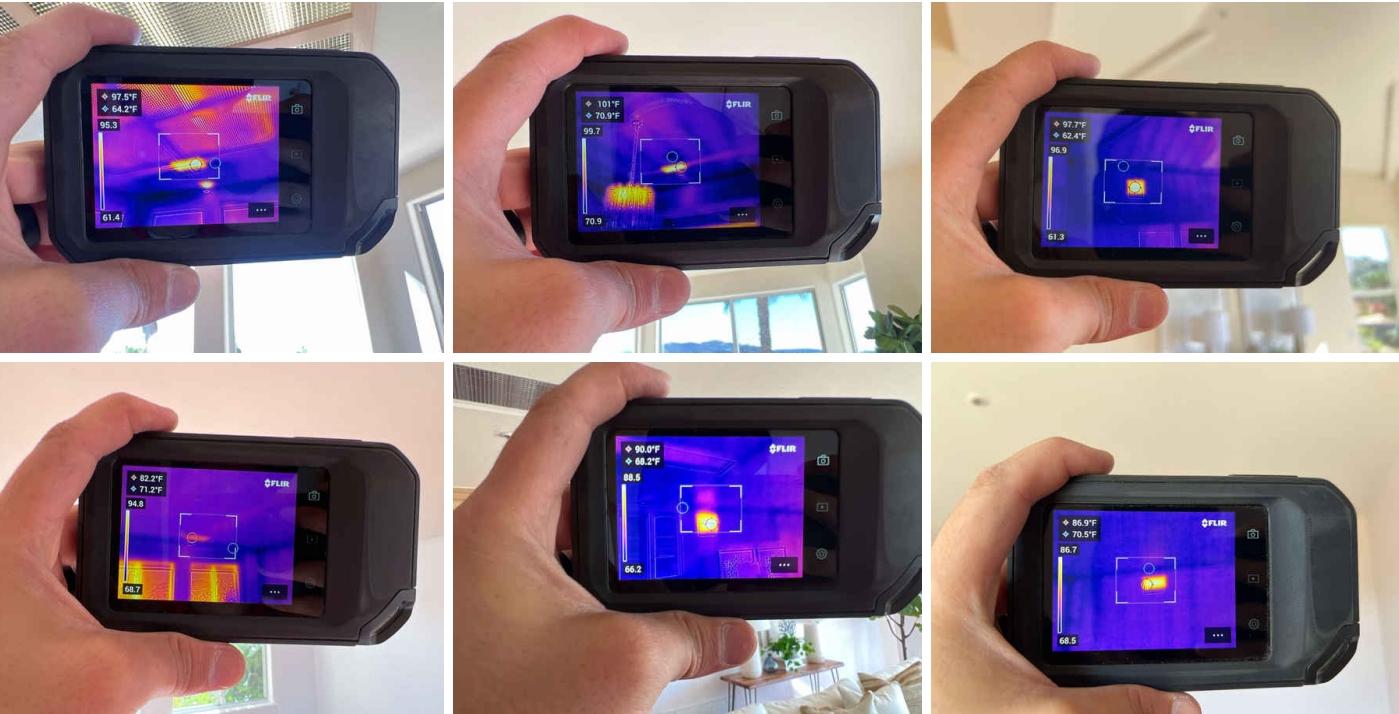
Distribution System: Heat Temp

The differential split is the number of degrees the system is heating (or cooling) the house air. Normal range for this number is 20 - 50 degrees when operating the system during cold weather. The system functioned as expected when tested and appeared to be serviceable at the time of the inspection. As with all mechanical equipment, the unit may fail at any time without warning. The inspector cannot determine future failures.

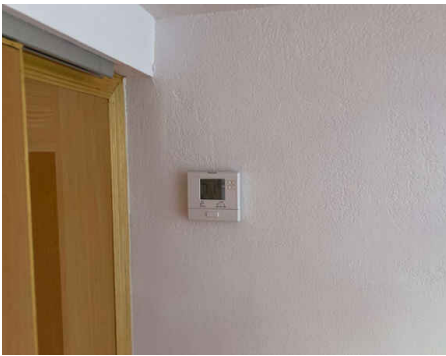
Thermostat: Thermostat

HVAC is designed with dual zone controls. Upper and lower thermostats control single system. See seller for more information.

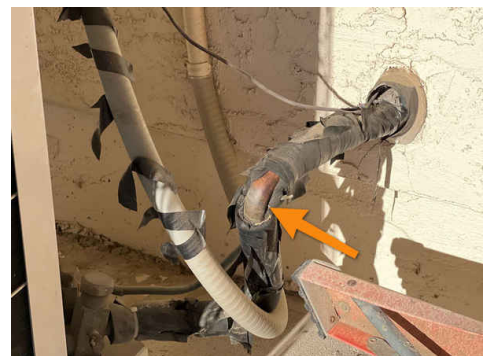
Missing or damaged insulation on refrigerant line. This can cause energy loss and condensation or icing of the line. Recommend repair/replace insulation as needed on the entire line.

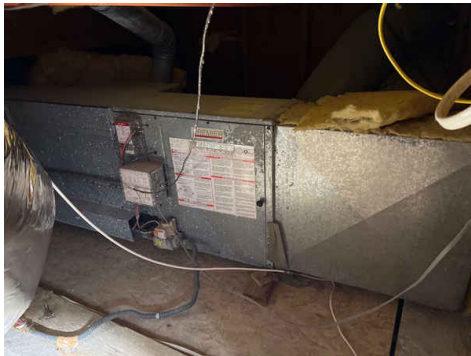
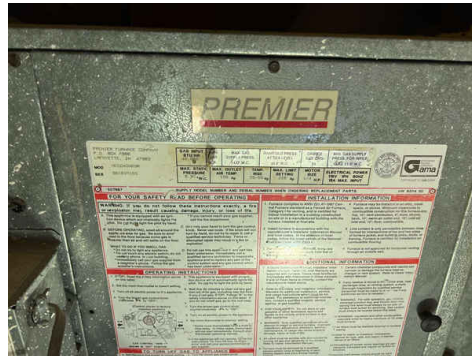
Horizontal furnace located in the attic. Appears to be on the CPSC list of recalls. Recommend licensed HVAC pro reevaluate entire unit and make any and all repairs.

Contact a qualified HVAC professional.

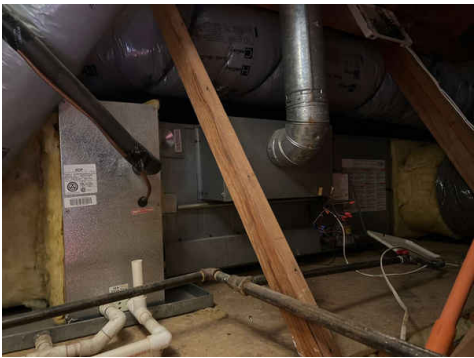
Horizontal furnace located in the attic. Appears to be on the CPSC list of recalls. Recommend licensed HVAC pro reevaluate entire unit and make any and all repairs.

Contact a qualified HVAC professional.

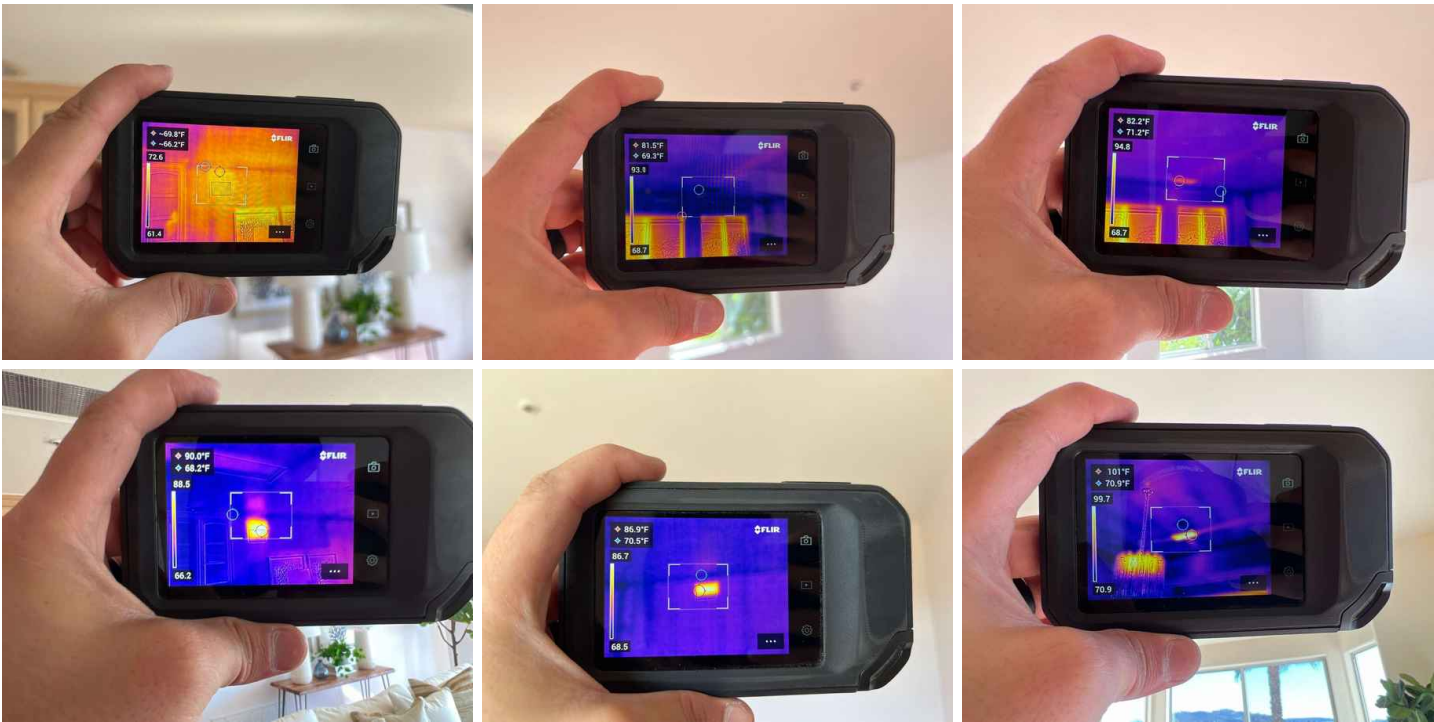
The differential split is the number of degrees the system is cooling (or heating) the house air. Normal range for this number is 14 - 20 degrees when operating the system during hot weather, lower when ambient temperatures are lower. The system did not respond within these parameters at the time of the inspection. Recommend an evaluation of the entire system by an HVAC company.

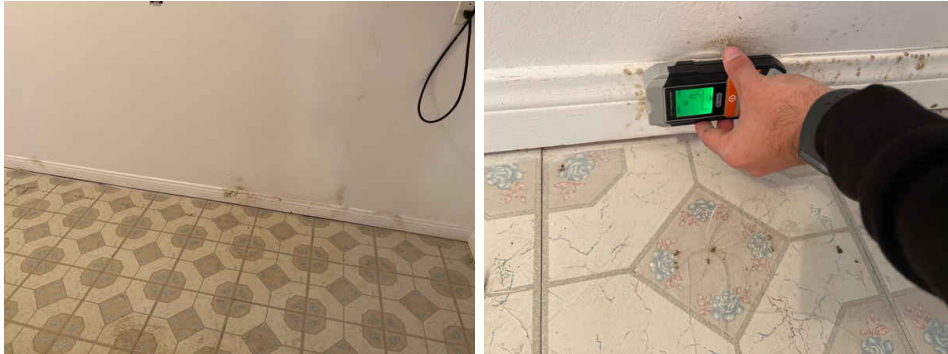
There are stains noted to the garage wall/ceilings. This can potentially be due to past or current water intrusion. Stains tested dry at the time of inspection. Recommend further investigation and repairs as needed.

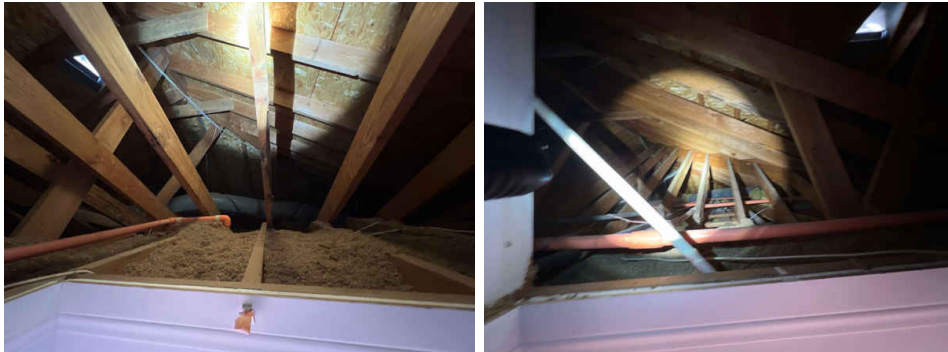
6.2.1 Firewall

FIREWALL ATTIC ACCESS

Attic access noted in the garage, breaks firewall. Recommend repair as needed.

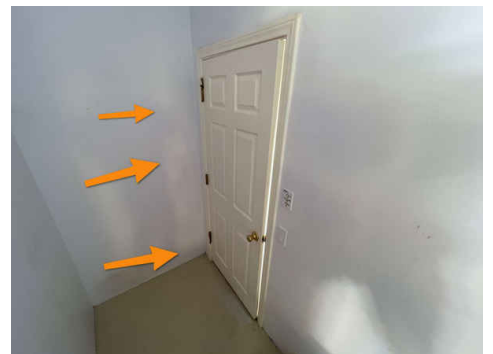
The interior garage door has a self closer installed, however it does not close and latch properly. Recommend adjusting/tightening as needed.

Contact a qualified professional.

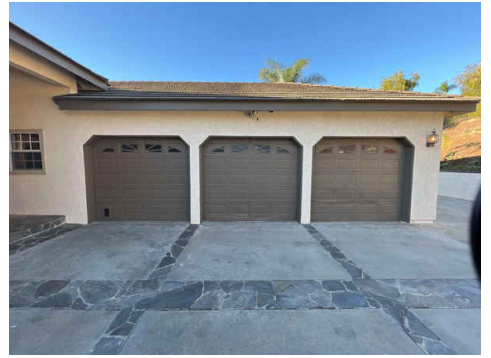
There are dents/dings noted to the garage door in areas.

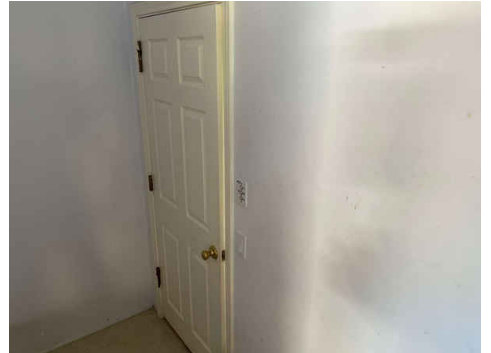
Wall switch needed to be depressed until door was open/closed. Recommend a garage door specialist evaluate & repair.

[Here is a DIY resource](#) to troubleshoot first.

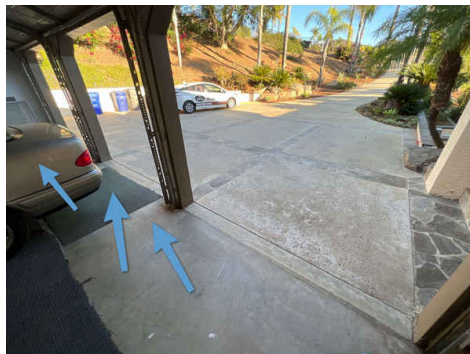
There appears to be an older model garage door opener without the eye beam system.

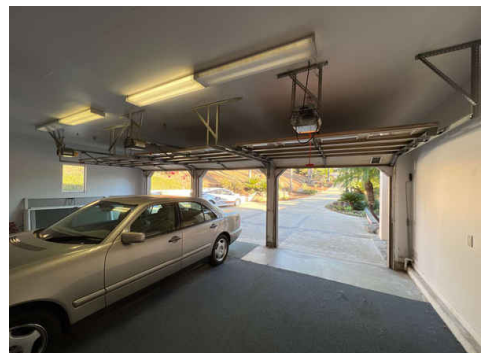
Garage door sticks for a period of time before opening/closing. This can be due to old opener batteries, old sensors or switches, or obstructions in the wheel track. Recommend a qualified garage door specialist evaluate to ensure cables, springs & motors are in working condition and properly lubricated.

[Here is a DIY troubleshooting link.](#)

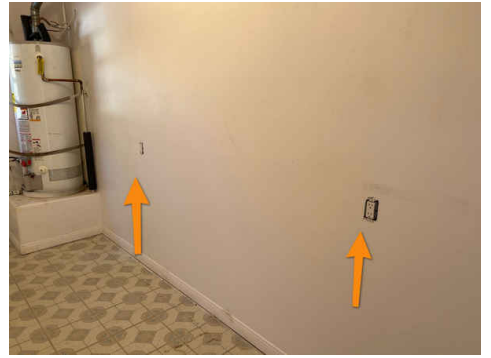
Receptacle(s) have a damaged/missing cover plate. Recommend replacement.

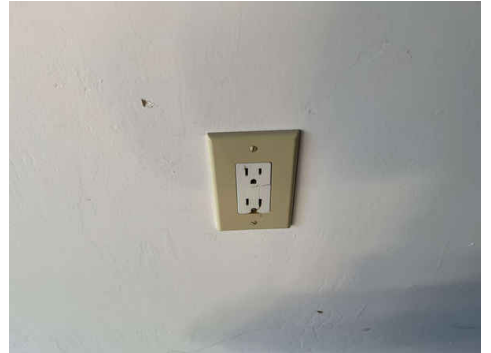
No GFCI protection present. Recommend a qualified professional upgrade by installing ground fault receptacles in all locations needed.

Contact a qualified professional.

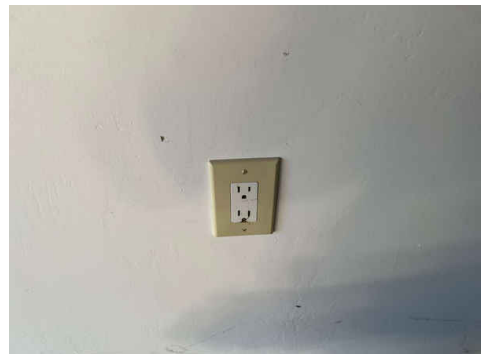
Garage

Damaged/cracked outlet noted in one or more areas. Recommend licensed Electrician re-evaluate and make any/all corrections.

Contact a qualified electrical contractor.

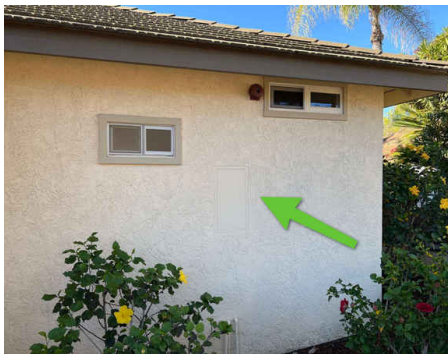
Internal fire suppression: Fire sprinkler

Fire sprinklers noted in home, system was not part of this inspection. If buyer is concerned recommend further evaluation by an expert.

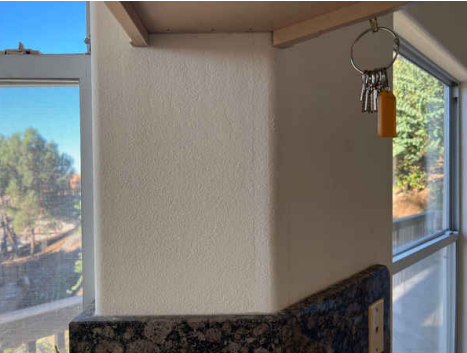
Kitchen

Cracks were observed in the home, it appears to be the result of long-term settling and or heat expansion and contraction. Some settling is not unusual in homes.

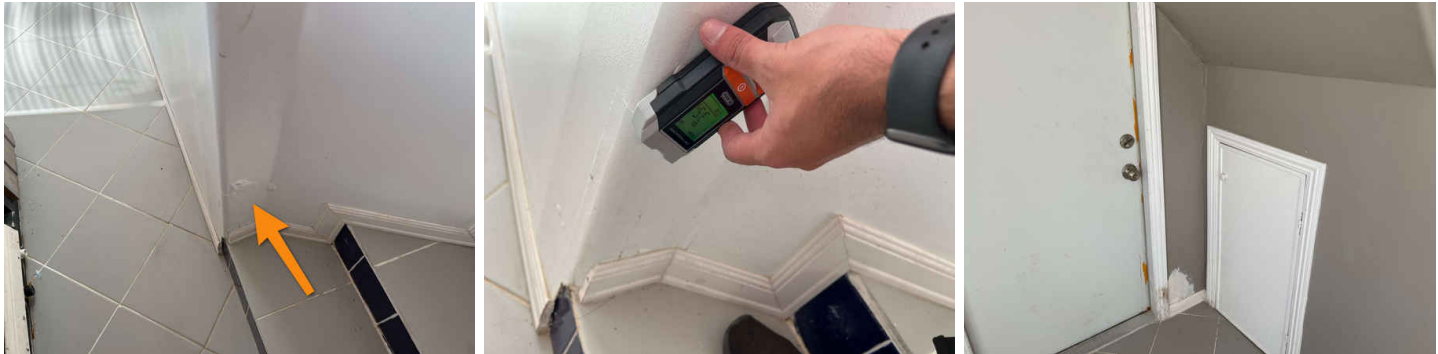
7.5.3 Walls & Ceilings

STAINS - TESTED DRY

Stain(s) were observed, they tested dry at the time of the inspection. Recommend further evaluation to identify source of leak and proper repairs have been made.

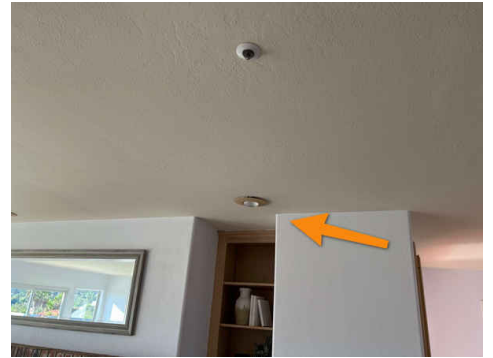
Light fixture doesn't appear to be attached to the wall/ceiling. Recommend repair.

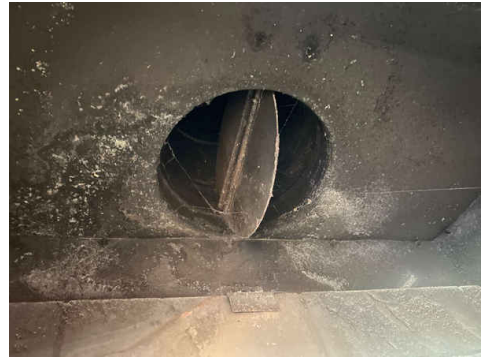
Chimney liner had layer of creosote dust, so underlying structure couldn't be inspected. Recommend qualified chimney sweep company inspect and/or clean.

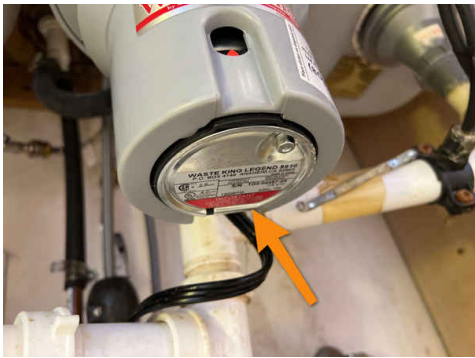
Active leak noted at the garbage disposal. Recommend repair by qualified plumber

Recommendation
Contact a qualified professional.

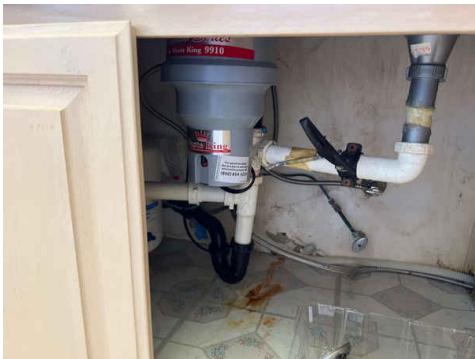
8.3.2 Garbage Disposal

GARBAGE DISPOSAL- INOPERABLE

Garbage disposal was inoperable at the time of inspection.
Recommend qualified handyman repair.

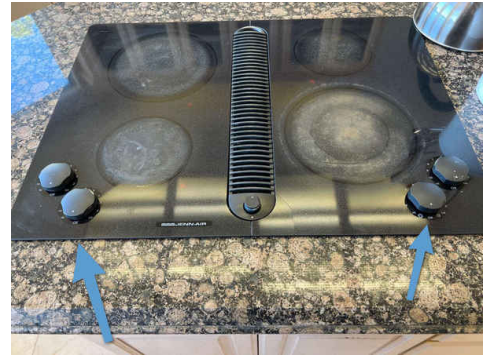
STOVE CONTROLS- WORN

Stove controls are worn, recommend repair as needed.

Contact a qualified professional.

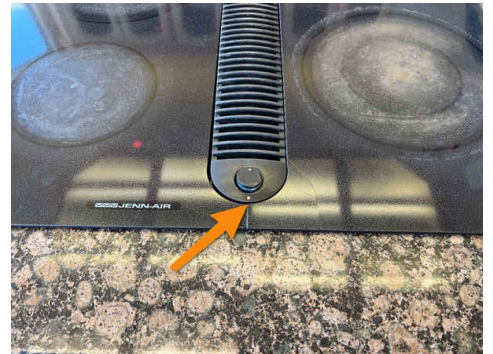
The vent fan control knob/button was damaged/missing at the time of inspection. Recommend repair/replacing as needed

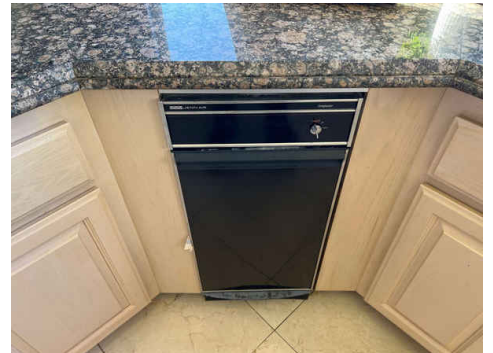
8.11.1 Compactor

NOT OPERATING

Compactor did not operate properly, recommend repair/replace as needed.

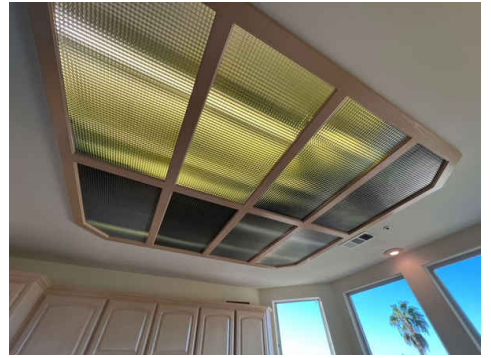
8.12.1 Switches & Light Fixtures

LIGHTS DNR

Light(s) are not operating properly to test, possible burnt light bulb(s). Recommend replacing bulb(s) and rechecking.

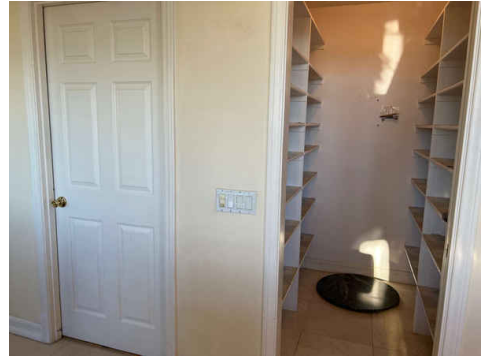
8.12.2 Switches & Light Fixtures

**COVER PLATES
DAMAGED/MISSING**

Switches have damaged/missing cover plate(s). Recommend replacement.

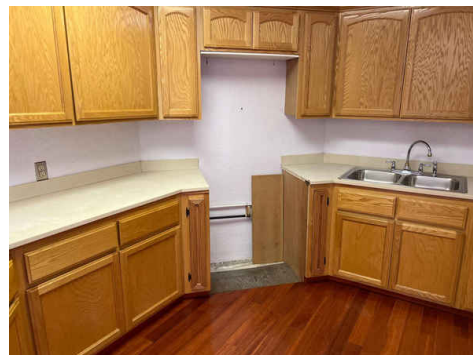
MISSING

Cooktop has not been installed.

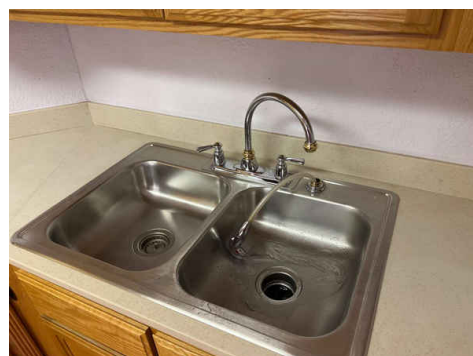
The sink faucet was difficult to operate at the time of inspection. Recommend repair as needed by qualified person

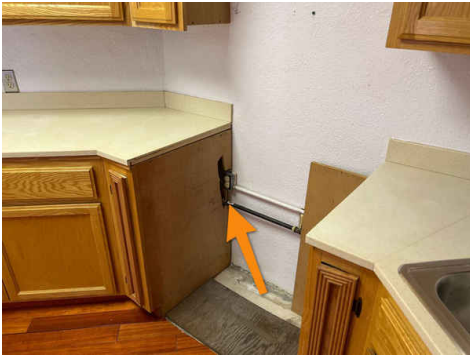
COVER PLATE- DAMAGED/MISSING

Receptacle(s) have a damaged/missing cover plate. Recommend replacement.

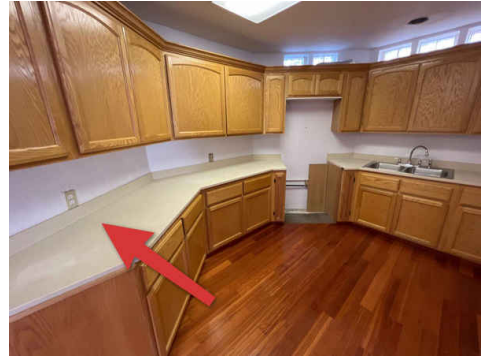
9.9.2 Receptacles & GFCI's

NO GFCI PROTECTION

No GFCI protection present at one or more outlets. Recommend a qualified professional upgrade by installing ground fault receptacles in all locations needed.

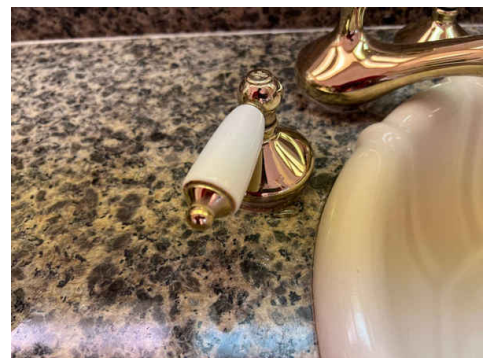
Leak was observed at faucet, recommend repair/replace as needed.

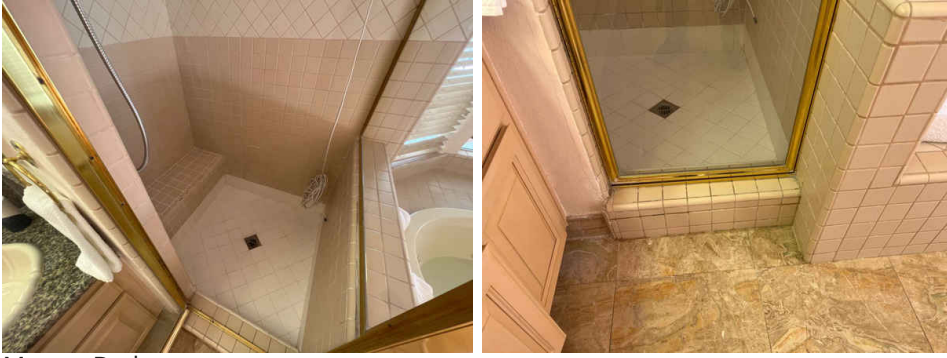
Missing/damaged grout and or caulking. Recommend maintenance of grout and/or caulking to prevent water seepage.

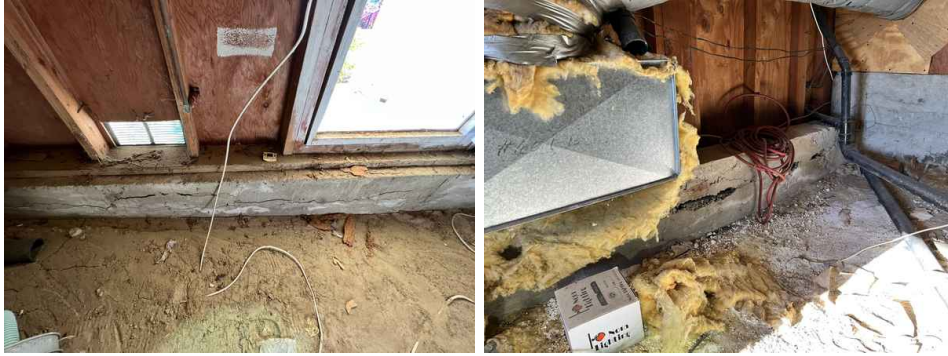
Cracking noted at the foundation. This is typically consistent with soil movement and could lead to damage to structural components. Recommend a structural engineer or a soils engineer evaluate and provide a report on course of action and remedy.

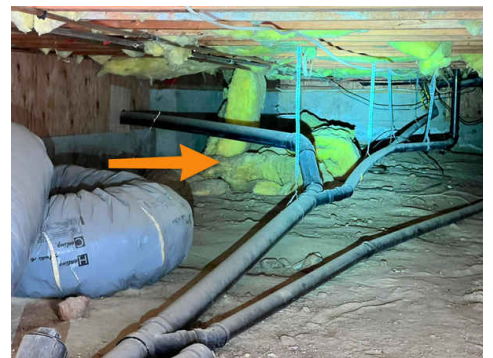
11.5.1 Insulation

OUT OF PLACE

Insulation was observed to be missing or out of place in area(s). Recommend repairing to promote proper insulation and increased efficiency of home.

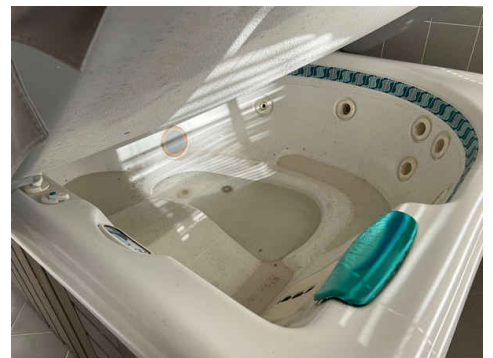
Pool/spa was empty at time of inspection. Inspector conducted a visual inspection of the surface but was unable to conduct full inspection on the pool. Recommend further evaluation by a pool company/specialist.

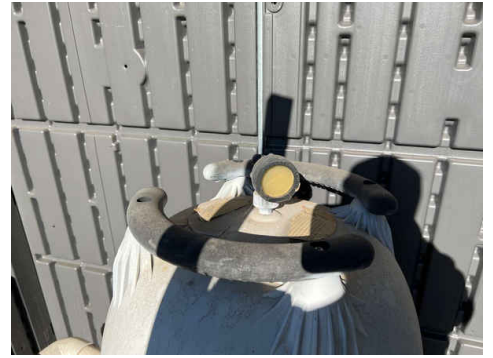
Filtering/Cleaning Type:

UNABLE TO READ PRESSURE GAUGE

Inspector was unable to read read pressure gauge, recommend cleaning or replacing.

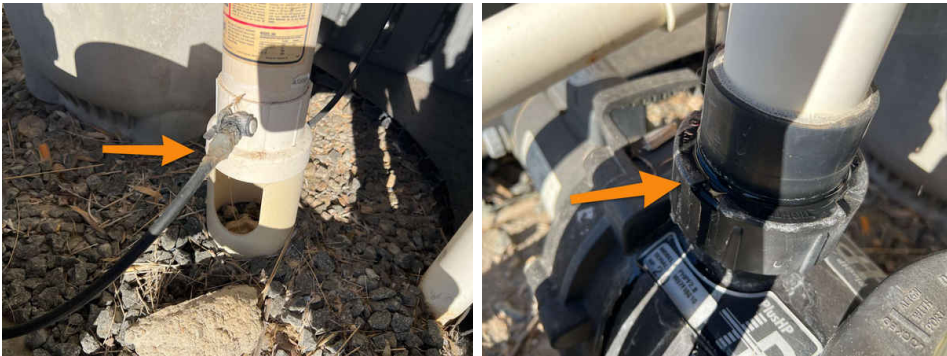
12.5.1 Plumbing

LEAK - MINOR (-)

Minor leak(s) noted in piping/valve(s)/pump(s), recommend evaluation and repair.
